TECHNICAL BULLETIN

MILITEC-1 IN A CATERPILLAR 988B LOADER

February 26, 1992

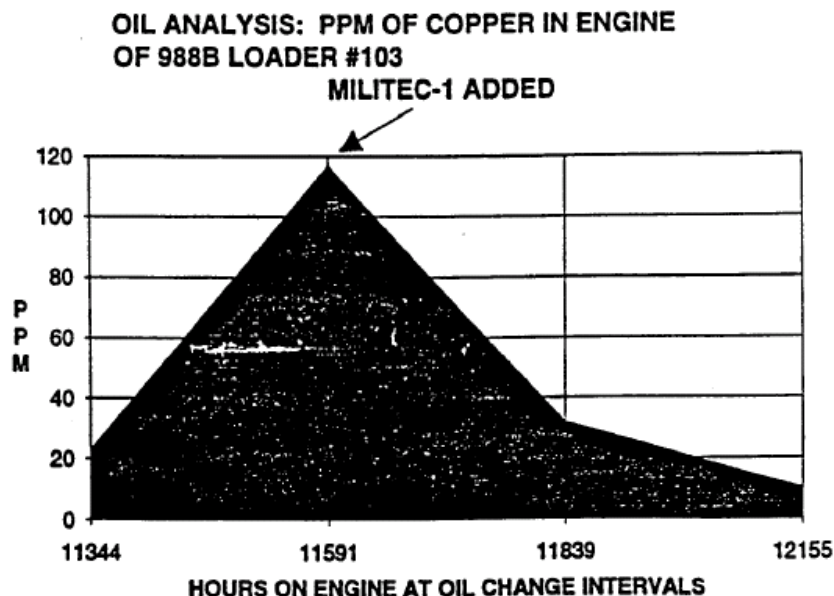
Results from Caterpillar #103, Primary Engine:

Cat #103 was treated with MILITEC-1 at 11591 hours on the engine. At this time, the oil analysis was indicating Copper levels at the extremely high level of 117 parts per million (PPM). Copper is monitored as an indicator of abnormal wear of engine thrust washers, bushings, and bearings. This provides an excellent indicator of damage occurring to the load-bearing areas of the engine. According to the head of fleet maintenance, extremely high copper levels sound the loudest alarm of all the metals monitored for wear and will result in immediate action. At this time, it was decided to treat the engine with MILITEC-1 to see if the levels could be brought down. After treatment, the engine started up noticeably easier and ran smoother.

period of 248 engine hours after which it was returned to the garage where the oil was changed and resampled. The oil analysis at 11839 hours indicated the Copper level was at 32 PPM, a drop of 85 PPM in one oil interval, but still in the high range. The drop of 85 PPM was outstanding according to the head of fleet maintenance.

The Cat was returned to operation for an additional period of 250 hours, **without any additional treatment of MILITEC-1**. Following this period, #103 was again sampled and the Copper level had fallen to 10 PPM. According to the head of fleet maintenance, this total drop of 107 PPM over two oil intervals clearly demonstrated the ability of MILITEC-1 to dramatically reduce wear in the most extreme of environments.

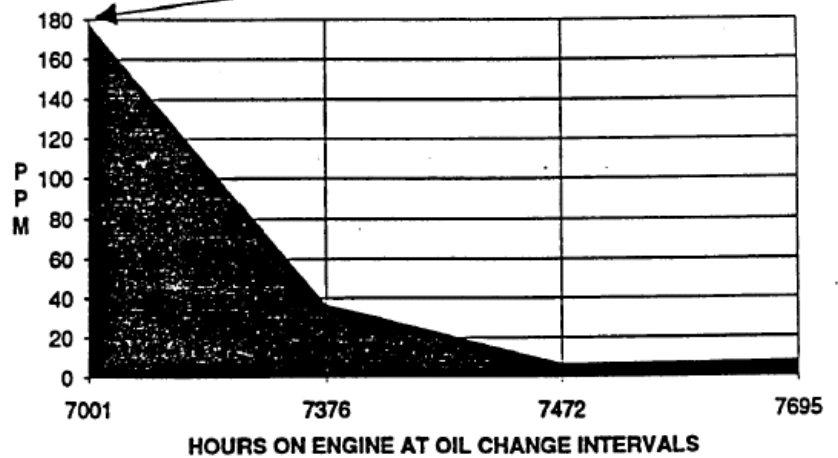
**OIL ANALYSIS: PPM OF COPPER IN ENGINE OF 988B LOADER #105
MILITEC-1 ADDED**

At 7001 hours on the primary engine, Cat #105 was showing a Copper level of 178 PPM, in the extremely high range. This indicated abnormal wear of the thrust washers, bushings and bearings in the engine and dictated a resampling after 250 hours to determine if extreme measures were called for including an engine overhaul. It was decided to treat the engine with MILITEC-1 at this time to see if any wear reduction could be recorded.

Following 375 hours, the engine oil was resampled. The period was longer than initially planned due to demand and another loader breaking down. At 7376 hours, the Copper levels had fallen to 37 PPM, a drop of 141 PPM in one oil change. According to the head of fleet maintenance, this was unexpected as they felt MILITEC-1 might have a chance of saving the engine, but that it would probably break down from the existing wear. The equipment was serviced and returned to the coke pits.

Following an additional 96 hours of operation, the engine was resampled. At 7424 hours, the Copper levels had fallen to 7 PPM, a total decline of 171 PPM (96%) over 469 hours of operation with MILITEC-1.

Since these results, an additional 223 hours have been put on the engine with the most recent analysis occurring at 7695 hours. The Copper level in this sample was 8 PPM, well inside the comfortable range.

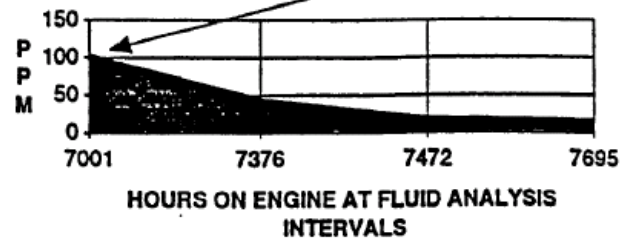
**TRANSMISSION FLUID ANALYSIS: PPM OF COPPER IN ENGINE OF 988B LOADER #105
MILITEC-1 ADDED**

At 7001 hours, when MILITEC-1 was added, the Copper level was 104 PPM, in the extremely high range for such a transmission. Also, the Iron level was 26 PPM, in the slightly high range. The elevated iron readings indicated wear on the shaft and gears which foretold premature transmission failure.

Following 375 hours of operation, the transmission fluid was resampled. At 7376 hours, the Copper level had fallen to 46 PPM, still in the high range but nonetheless a dramatic decline. The Iron level had dropped to 11 PPM which was in the average range.

Following another 96 hours of operation, the transmission fluid was again sampled. At 7424 hours, the Copper level had fallen to 22 PPM, in the slightly high range. The iron had dropped to 9 PPM, slightly below average.

After another 223 hours of operation, the transmission fluid was again sampled. At 7695 hours, the Copper level had fallen to 19 PPM, in the slightly high range but extremely low for this transmission, given its historically high levels. This was well enough in the comfort range that drastic action was no longer contemplated to save the transmission. The Iron level had remained at 9 PPM, indicating no significant wear was occurring.
